# XRipper®: Trouble-free wastewater transport despite hygiene articles

## Case Study - Lautertal municipality

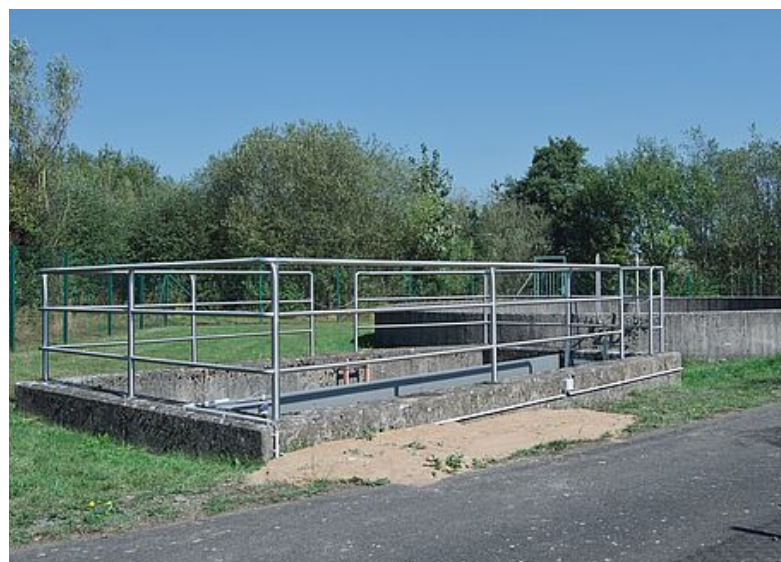
This system has proven itself for years. However, the increasing use of new hygiene items (wet wipes) and grooming products (microcloths), have pushed the system to its limits, until it was impossible to reliably prevent impurities from entering the pumps. Over the last five years, this has led increasingly to clogging and faults. Particularly during heavy rain events, many impurities are washed into the pumping station where they become a problem.

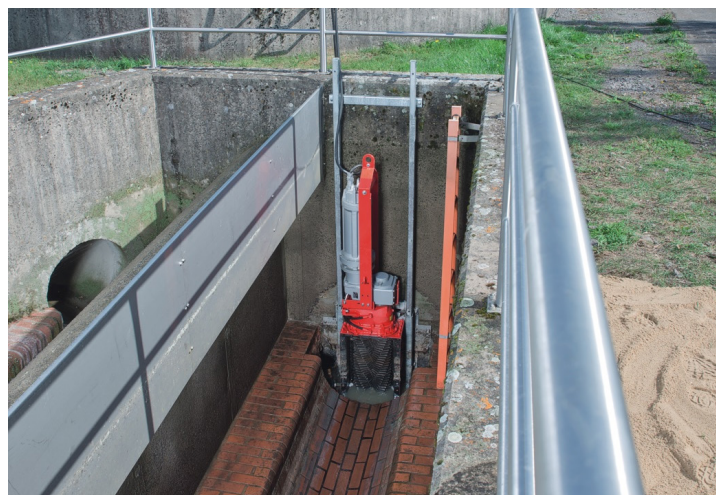
To reduce the cost and workload of these disruptions, a test installation of a Vogelsang XRipper XRC-SIK was fitted in the open collective shaft before the buffer pool. The waste water passes through the XRipper unhindered, while the disruptive matter in the shaft is held back. The XRipper was switched on by means of ultrasonic level monitoring and reliably macerated all the disruptive matter to a manageable size. This reduced maintenance work for the employees and to date (February 2017) there has been no further trouble. The macerator was adopted by the municipality after the end of the 3-month trial period.
